CASE STUDY: APPRAISAL OF FOUR SOIL-BASED METRICS IN THE ESTABLISHMENT OF SUSTAINABLE UPLAND GRASSLAND AT A MINE SITE IN SOUTH WALES, UNITED KINGDOM¹

R. Neil Humphries,² Robert J. K. Thompson, and Mark D. Heames

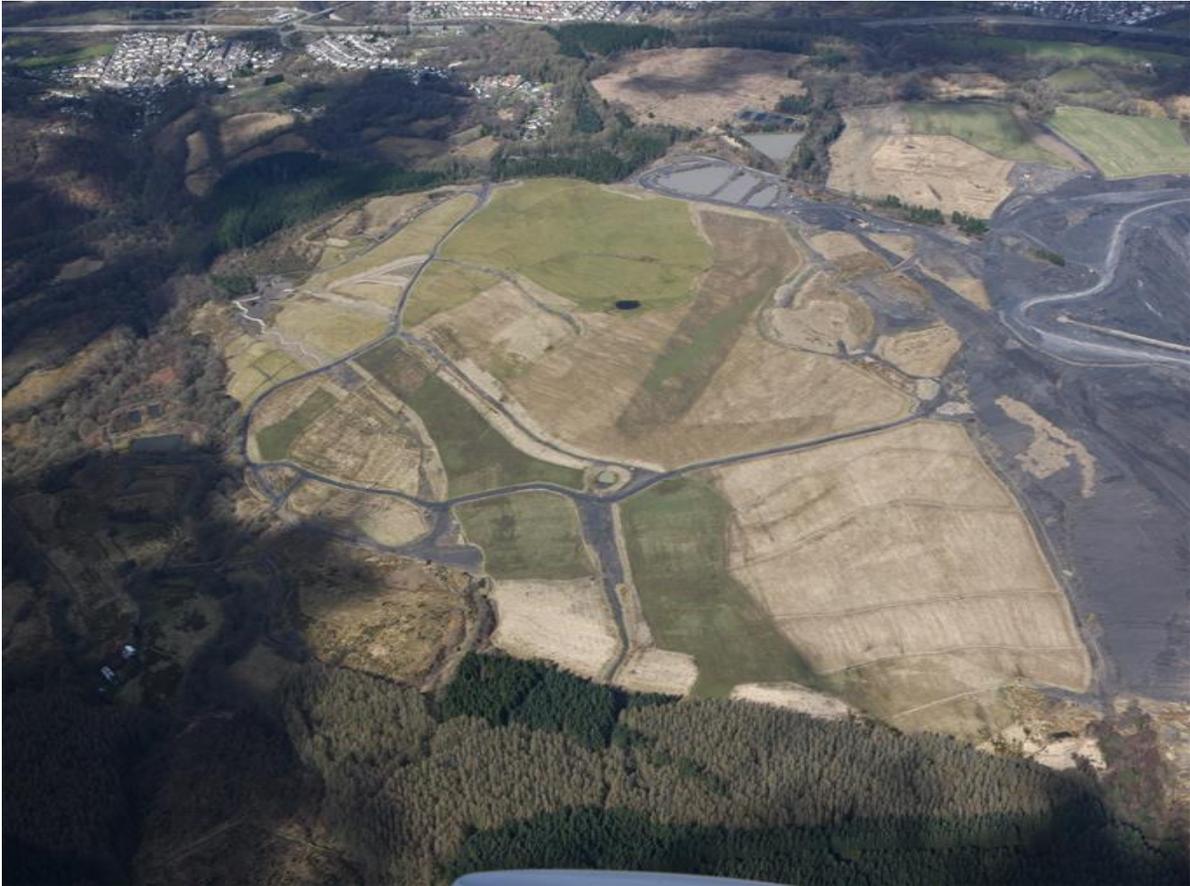
Photo 1. Mosaic of land use and habitats (including upland acidic grassland) established on progressively rehabilitated land between 2006 and 2013 (aerial photograph taken in early 2017).

The Selar Surface Coal Mine in South Wales started working in 1997 and completed its final coaling operation in 2018. Rehabilitation has been undertaken progressively since 2006 as overburden was backfilled and soil material placed (Photo. 1).

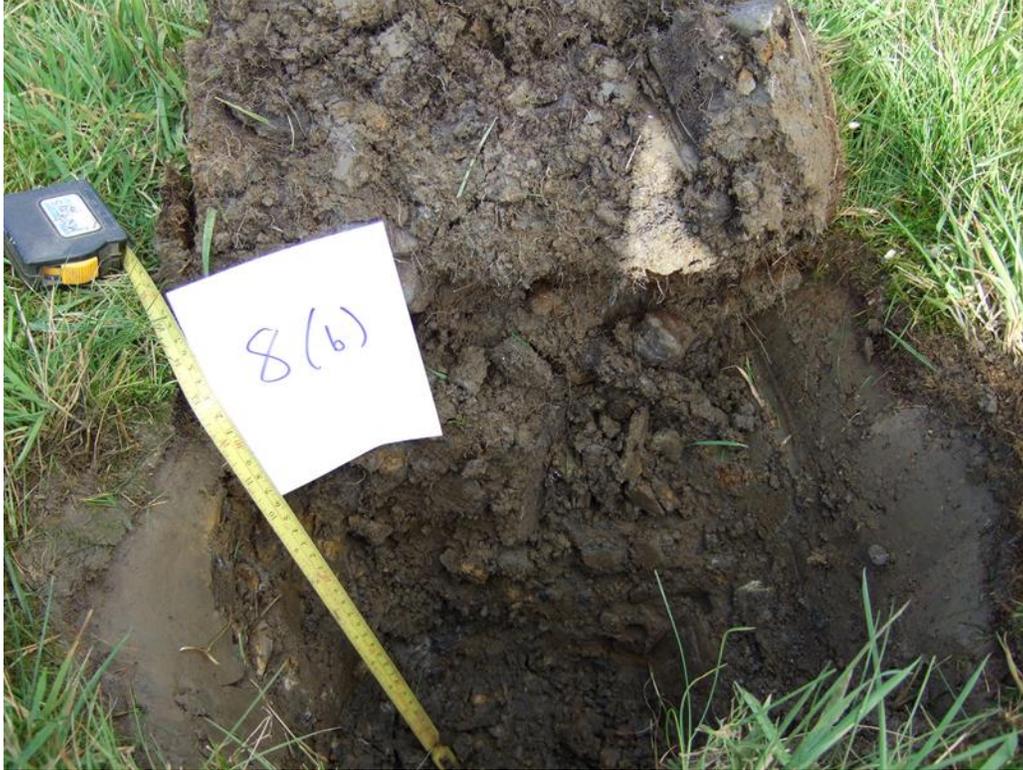
Photo 3. Compartment 8 replaced 'subsoil' layer exhibiting the development of a medium sub-angular block structure by the end of the 5-year aftercare period.

The structural development in the upper profile in all cases was either weak blocky or not visually evident (i.e., apedal) and limited to cracks and root channels, as reflected by the high packing density.

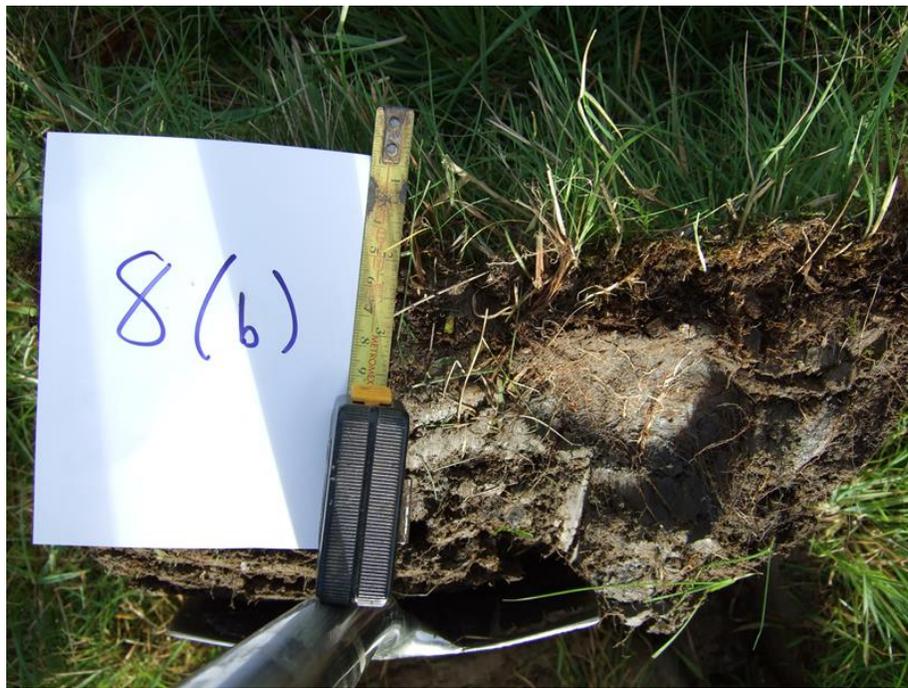
Photo 4. Compartment 8 replaced soils exhibiting the *Very Poor* category of VESS Index for the 'topsoil' layer.

The methodology differentiated between three groups of samples, being either Index 3 (Adequate), 4 (Poor), or 5 (very Poor) owing to their soil (structural) aggregate size and shape in the upper soil layer (Photo. 4).
